# Learning Brief: #024

Date: 22/06/2022

## Incinerator Fire

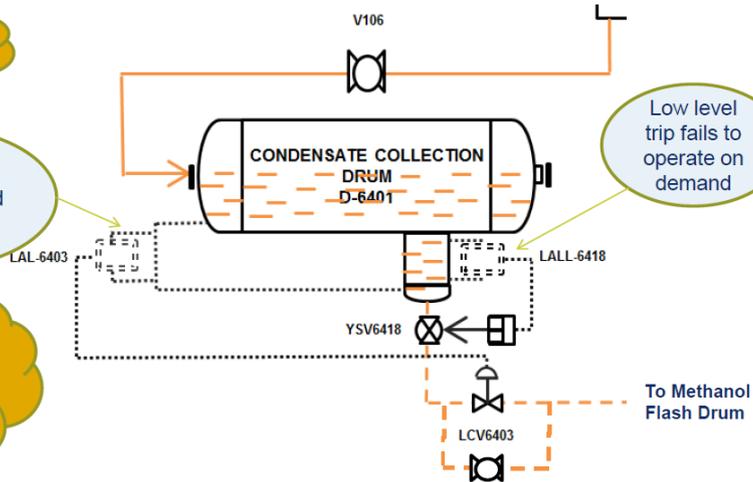
Level gauge was in bypass as control valve was non-functional.

Work around solution culturally driven

Low level alarm did not activate (alarm set at 10%)

Low level trip failed to operate, allowing condensate to leave drum via the open bypass.

Failed due to particulates and 14% in S>G

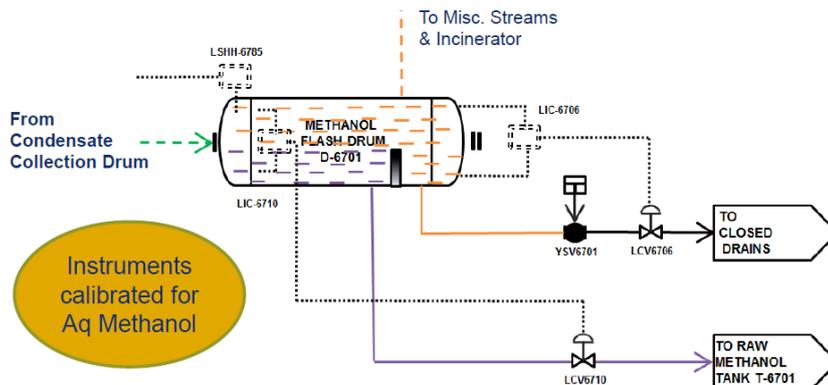
Level control (aqueous side) failed to contain the rising level in the vessel. High alarm activated at an indicated 85% - trend remained level

Level control (condensate side) was not in auto control being in manual and control valve was latched closed

High alarm activated, level indicated 75% - trend remained level

High High level trip failed to operate due to being specified for methanol, not condensate.

Instruments calibrated for Aq Methanol

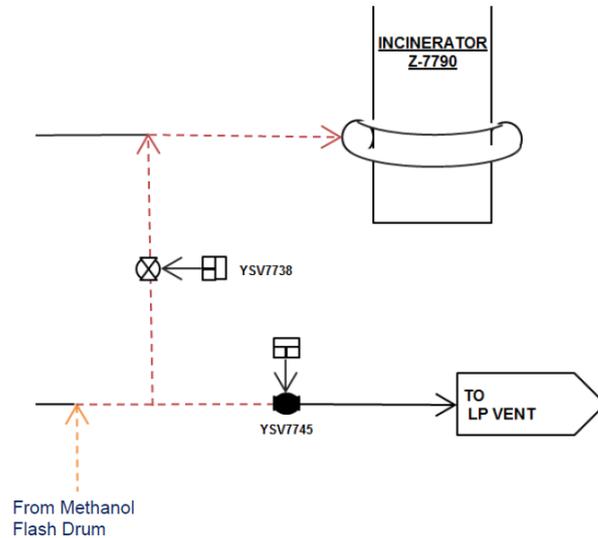
Isolation valve was manually inhibited on first sign of process upset in the incinerator

Result was that miscellaneous stream was not isolated when incinerator tripped
