# ATEX have we learnt from our mistakes?

## ATEX have we learnt our mistakes- Sharing our experiences

I am Declan Barry MD of ATEX Explosion Hazards Limited based in the UK and Ireland. Explosion Hazards has provided Explosion Safety Solutions to industry for over 42 years

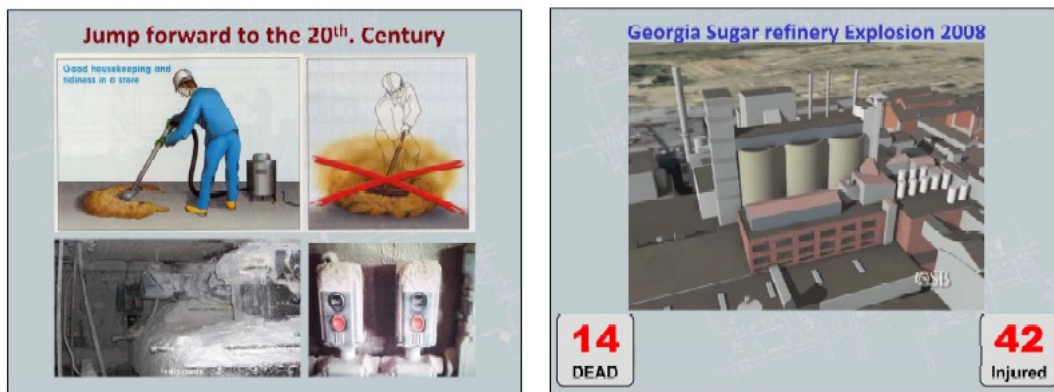
On 7 February 2008, an explosion, possibly caused by static electricity igniting fine sugar dust that had become too dry, at a Imperial Sugar refinery Port Wentworth, Georgia, killed 14 people and injured over 42. They had enclosed the bottom of the silo conveyor to prevent spillages, which subsequently blocked and acted as a confined path way for the propagation of the flame throughout the plant. This was the initial explosion path but the consequent fuel was provided by an un-clean plant and operators blowing down their machines with compressed air.

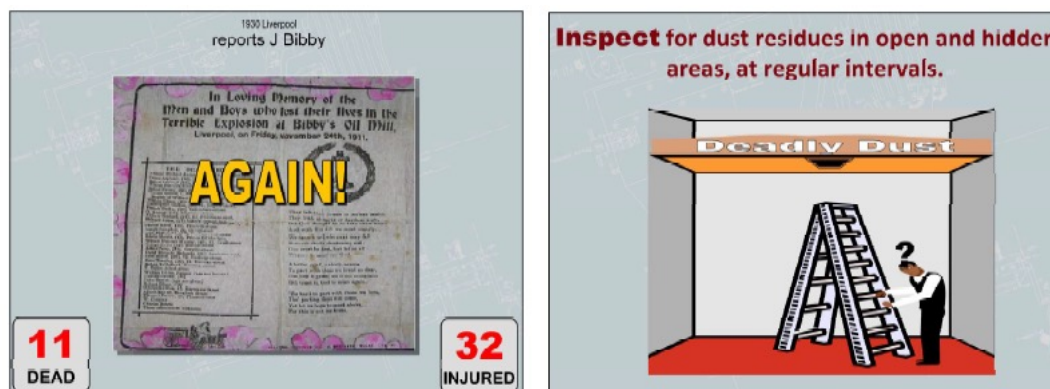
NFPA 654 –guidance: Provide access to all hidden areas to permit inspection. Clean dust residues at regular intervals. On February 20, 2003, an explosion and fire damaged the CTA

Acoustics manufacturing plant in Corbin, Kentucky, fatally injuring seven workers. The facility produced fibre glass insulation for the automotive industry. CSB investigators have found that the explosion was fuelled by resin dust accumulated in a production area, likely ignited by flames from a malfunctioning oven. The Workers had a clean plant below the false ceiling but the aspiration systems was extracting dust laden vapour into the false ceiling plenum, but the duct work above was not connected to the extract grills and the dust precipitated onto the back of the suspended tiles. An oven explosion disturbed all the dust over head and the extract system drew the flames into the ceiling void above. This caused a catastrophic factory explosion.

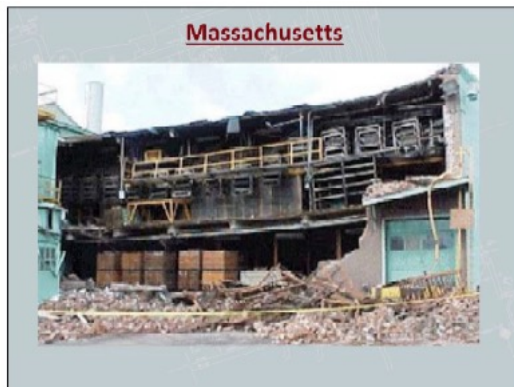
Massachusetts had a Fire in a foundry shell molding machine. This caused a primary explosion in ducts which containing heavy deposits of Phenol formaldehyde resin dust. This resulted in a dust cloud from the ledge dust deposits outside the ducts and a secondary explosion in the plant area.

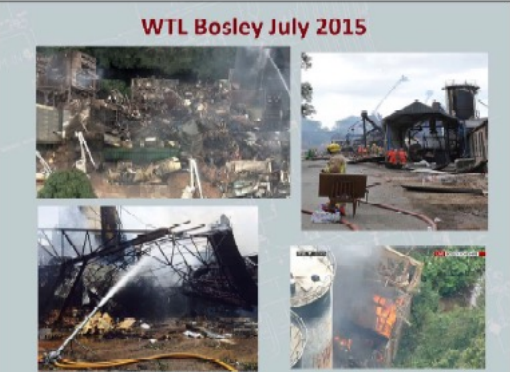
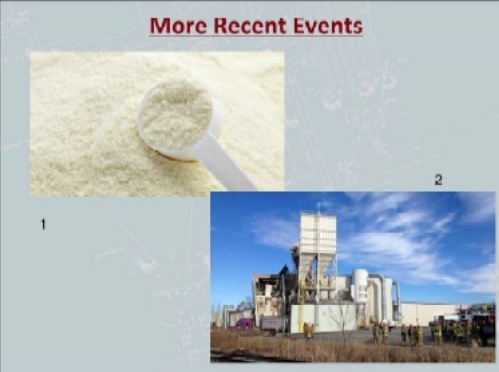
In the UK the most recent tragic event at Boden Wood Flour Mills in Bosley Cheshire this July where the site was also struck by fires in 2010 and 2012. Wood was processed at the plant into a fine powder and the resulting “wood flour”, with a consistency like sand, is used to make laminate flooring. Only day’s later search teams had found the remaining bodies under the rubble. This highlights the need for closer scrutiny of wood as an explosive dust, especially as the larger power plants convert from coal to wood pellet biomass. The initial reports unqualified are complaints about the cleanliness of the plant, maintenance of the mills.

1. A worker at Adams foods in leek, Staffordshire, suffered facial burns in a powder explosion at the food factory assembly line on August 14<sup>th</sup>.
2. A collapse and fire at an Omaha plant in the USA which makes supplements for animals has injured at least 10 people and killed at least two. The Omaha Company has been fined at least twice before for safety violations, according to OSHA.

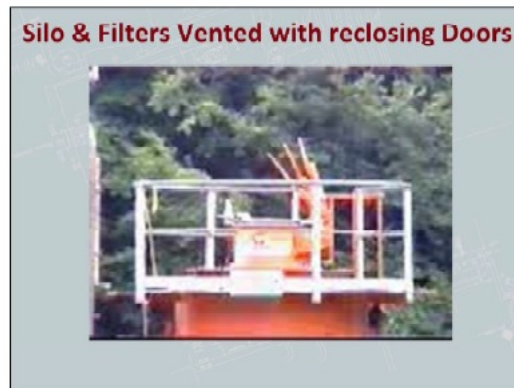
Explosion venting is always the preferred option if you can establish a safe vent area.

Although some modifications can be made to divert the path of dangerous flames they still have practical restrictions which need to be documented and enforced.

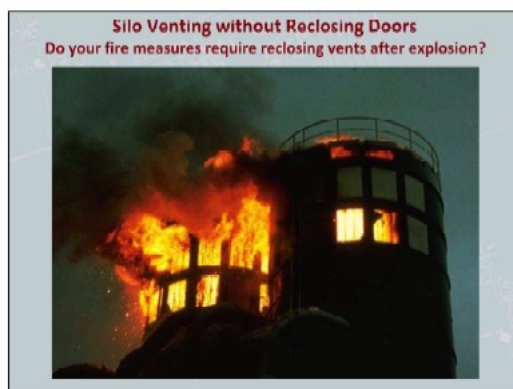
A Vented Explosion with self reclosing doors to prevent ingress of air after the event is desirable but expensive.

Vented Explosions without self reclosing doors can still have the air influx feeding the original fire and can reduce the effect of e.g. CO<sub>2</sub> inerting systems

There are some common design flaws you should check, in any new or existing vent systems. Are the filter bags blocking the natural path of the explosion vent efficiency?

Some filter manufacturers have type tested these arrangements but others have just ignored the restrictions. We have offered, where practical to add a wedge beside the dirty volume of the filter. Although this may increase the dirty volume, it does direct the vent flame vertical, minimising the perpendicular reaction forces and ensuring full unobstructed vent efficiency.

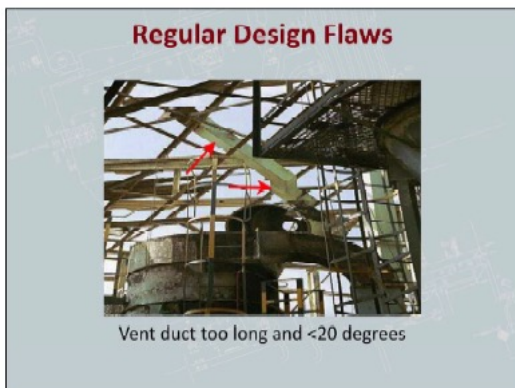
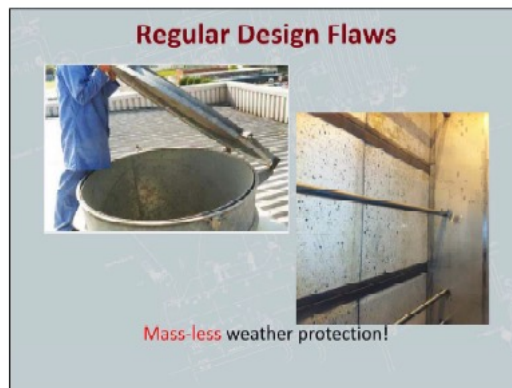
The introduction of explosion vent ducts, to turn the explosion around obstructions or vertically from a normal horizontal path, can create 400% back pressure affecting the vent efficiency or creating dangerous missiles

Low cost rectangular vent panels cost only a few hundred pounds to supply but have to be replaced once fired. Even though you have allowed for vent ducts in the original calculations, many times covers are put on the end of the ducts to prevent ingress of weather or pests. This modification should be done by a competent persons using mass-less covers.

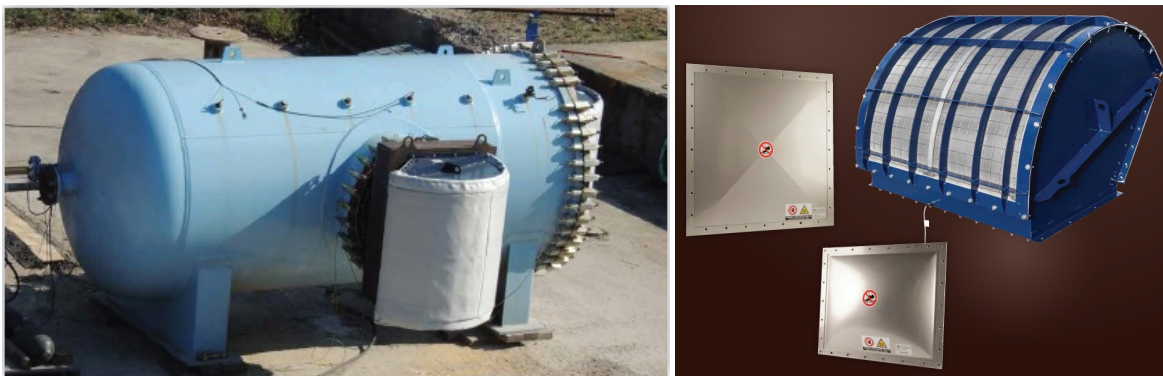
Rectangular vents with the new flameless vents for larger volumes it is a great alternative to explosion venting into a building with-out the dangers of open flame. The important thing to remember is the air is still displaced outside of the flameless vent so if you disturb enough dust outside it may find another ignition source.
