Process Safety Forum

Learning Brief #15 – Issued on 27th November 2015

Caribbean Petroleum Tank Terminal Explosion and Multiple Tank Fires

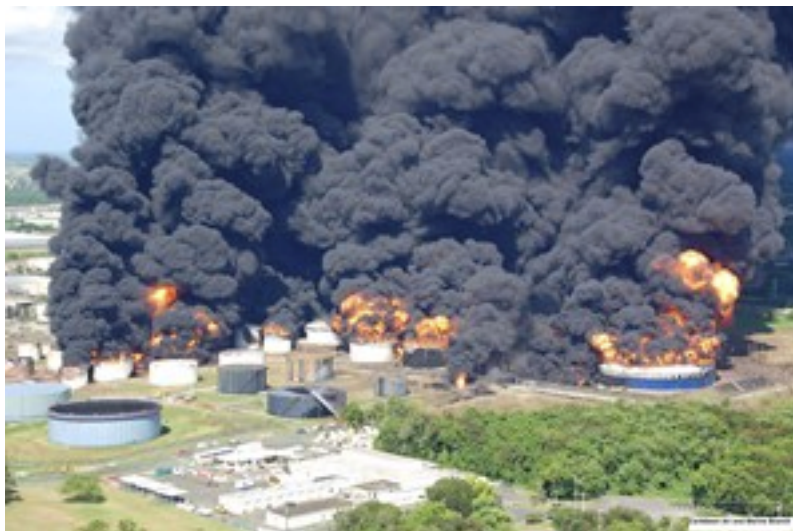
On the night of October 23, 2009, a large explosion occurred at the Caribbean Petroleum Corporation (CAPECO) facility in Bayamón, Puerto Rico, during offloading of gasoline from a tanker ship, the Cape Bruny, to the CAPECO tank farm onshore. A 5-million-gallon aboveground storage tank (AST) overflowed into a secondary containment dike. The gasoline spray aerosolized, forming a large vapour cloud, which ignited after reaching an ignition source in the wastewater treatment (WWT) area of the facility. The blast and fire from multiple secondary explosions resulted in significant damage to 17 of the 48 petroleum storage tanks and other equipment onsite and in neighbourhoods and businesses offsite. The fires burned for almost 60 hours. Petroleum products leaked into the soil, nearby wetlands and navigable waterways in the surrounding area.
